Ted's News

June 2018

[Another Great Timber Structure at Toohey Forest Park](#)

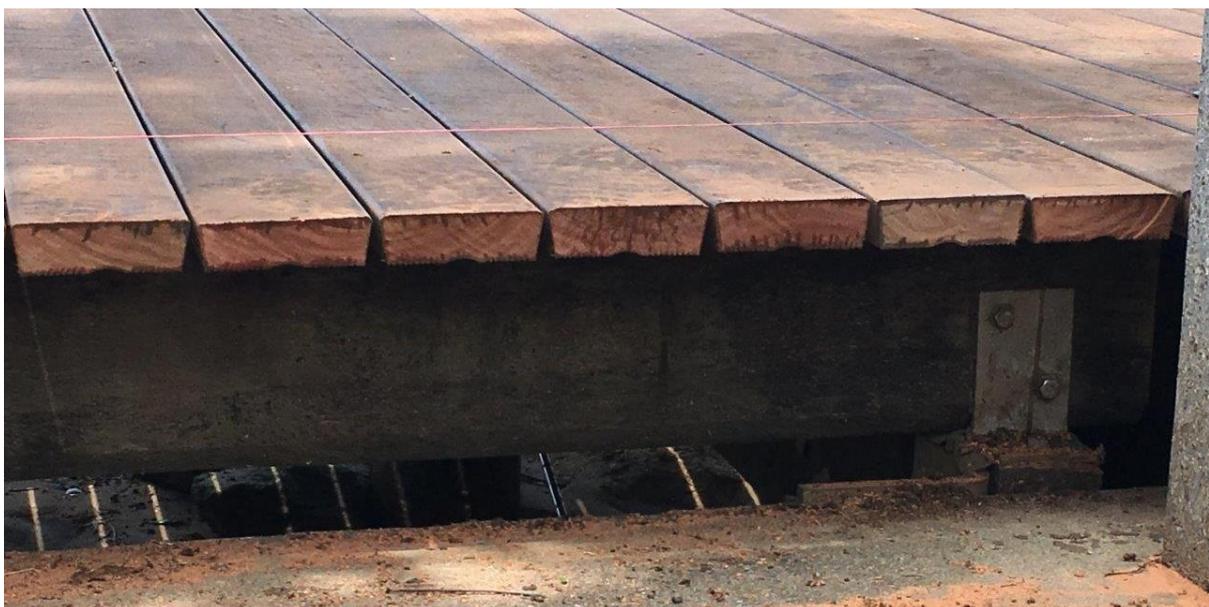
Why Deckwood was chosen

Image taken recently at Cairns Esplanade refurbishment where Deckwood was used because of its superior profile and specification

The decking is 120x35 Deckwood from [Wilson Timbers/Outdoor Structures Australia](#) who make the product under license. This size is chosen because:

- Its width to thickness ratio (3.4 to 1) means that it will not cup. (145x35 probably will)
- It gives better recovery from the logs
- It will carry 5 kPA, 4.5 kN loads at 600 mm centres
- The shrinkage in this unseasoned timber is not excessive and is laid without a gap normally
- The tapered sides make the deck self-cleaning
- The ripples and anti-warp groove provide maximum air flow at the joist
- The rough sawn face has been tested to R12 slip resistance

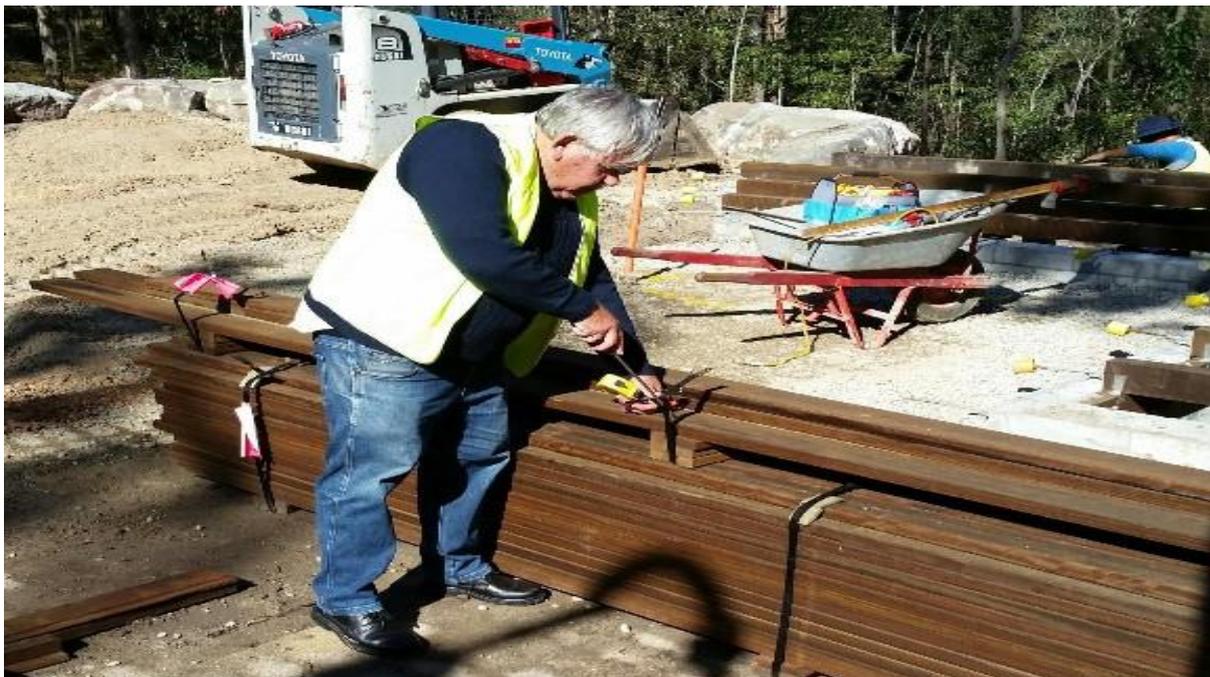
Grading the decking

An important part of any weather exposed timber structure's success is independent confirmation that the timber is supplied to specification. (Mind you, it must be the right specification.) Decking timber particularly has requirements that go far beyond roof trusses and so needs a much tighter specification. You get this with the Deckwood specification. My book [Grading Hardwood](#) explains in detail why vague specifications can easily end in heartache as AS2082 ignores the most important properties required for decking. I have rejected up to 50% of decking supplied by others to our specification (but not Deckwood profile). Just like you check your concrete for compliance, check your timber. There is no longer anyone checking the millers grading. I can do this for you as can others.

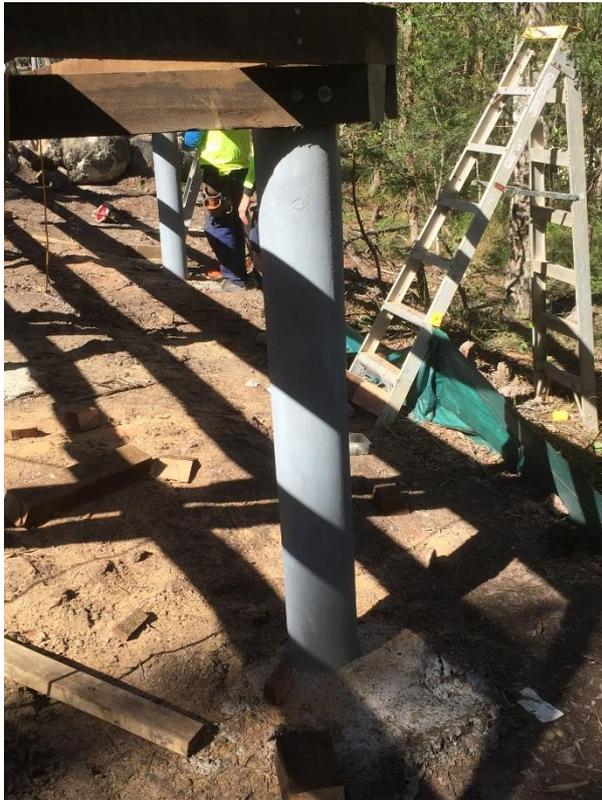
Posts

I have long advised against relying on non incised sawn treated pine if you are expecting a long trouble free life. [This old newsletter should settle the matter in your mind](#). However, true diameter rounds in pine are a very different beast altogether. Because there is a broad band of sapwood completely enveloping the low durability heart you can truly "preserve" this timber.

I usually supplied 150 mm diameter posts when I was trading but now recommend 200 mm regardless. I had control over what I purchased and made sure that I only used H5 but the same size was also available in the lower priced and easier to purchase H4. There was no way of telling the two apart. By contrast 200 mm is only available in H5

The Timber Life design prediction software gives this product a life expectancy of about 100 years in this location but CCA treated round pine posts have a fatal weakness, fire. Because of the arsenic content in the preservative they will continue burning after a quick grass fire as passed through. This possibility was recognised in this design and the posts had an intumescent paint applied.

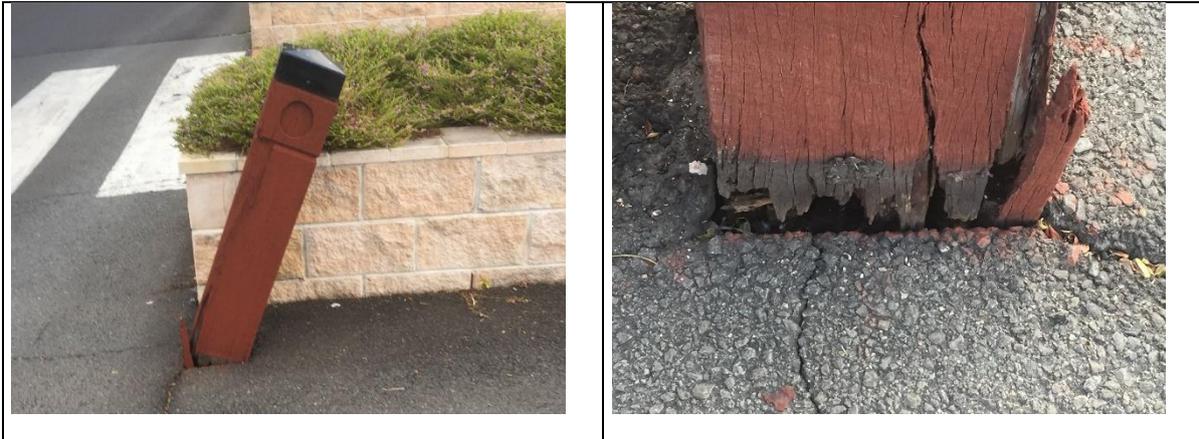
Your Design Sins Will Find You Out

I saw this failed 200x200 timber bollard in the main street of a country town that cannot be named less I get a "No Parking" sign put in the middle of my driveway. There are important lessons to be learnt and none of it was "secret men's business" at the time the project was undertaken.

Prior to 2001, the Council involved was updating the streetscaping and the proposal, all along, was that timber bollards would be used. Three people from the Council and one from a design company came to my office to find out what had to be done for these to be successful. I explained that it was very simple. All that had to be done was:

- Use Durability 1 in ground timber such as ironbark
- Not set them in concrete but use natural earth, fine crushed rock or no fines concrete
- Cut expansion grooves along the length to control the splitting, and
- Put a cap on the top.

The plans eventually came out and I was asked to quote on the supply and the detail was:

- Spotted gum timber (Durability 2 in ground)
- Set in concrete
- No expansion grooves
- No cap

I told the Council that I would not put my name to this product as they would not give satisfactory service but I would sell the timber to them and they could do with it what they will. Another company operating here at the time saw no problems and supplied the finished article and the bollards were installed contrary to known good practice at the time.

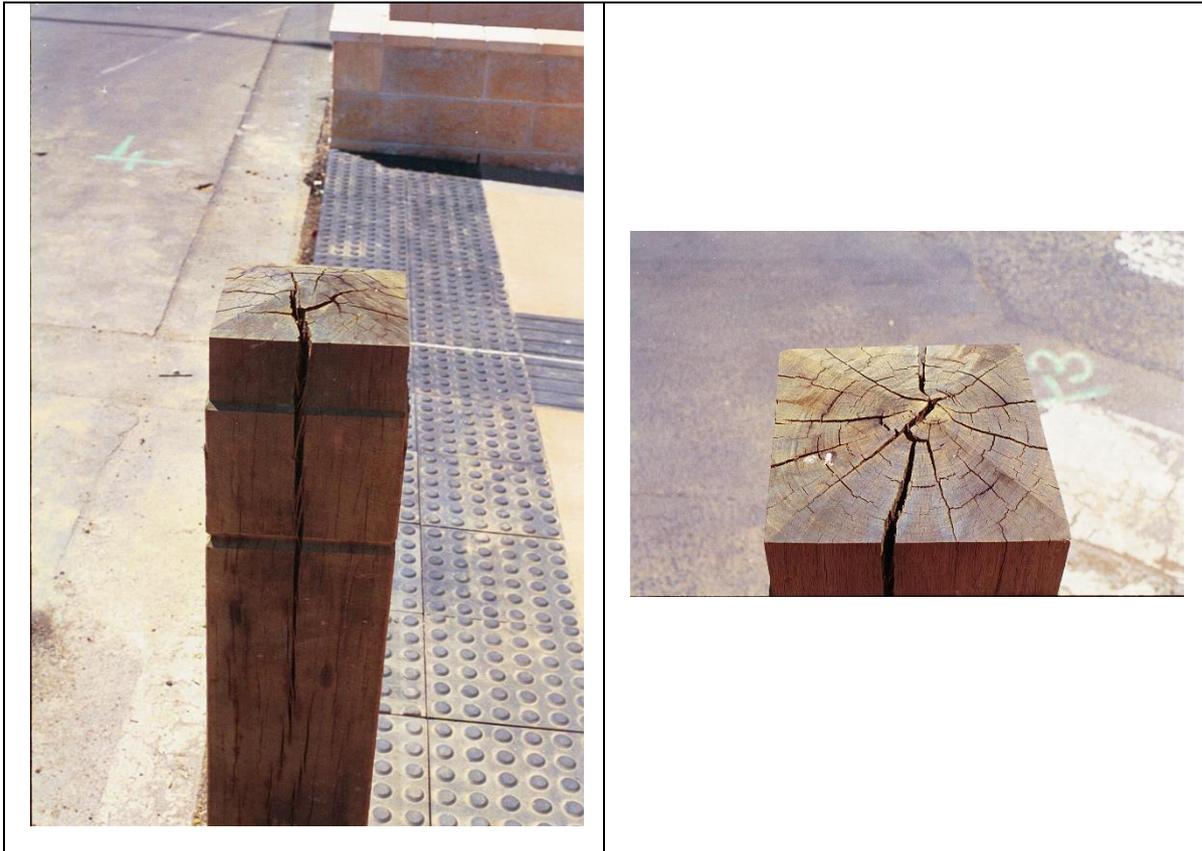
Soon after installation, the timber started splitting badly and the mayor approached me to supply the caps in around 2001. But, of course, the horse had already bolted.

Discussion will arise in the Council about the wisdom of using timber again because these posts are going to be very, very expensive to replace but this is not a timber issue, it is a failure to listen, check the documentation that was given at the time and adopt best practice. By contrast, the [ironbark cross at the Anglican Church](#) (also 200 mm thick) and supplied in 1967 is only now needing attention. Seeing the poor performance of this product led me to develop what we called the [Pioneer Post](#), which is still available from Wilson Timbers/Outdoor Structures Australia.

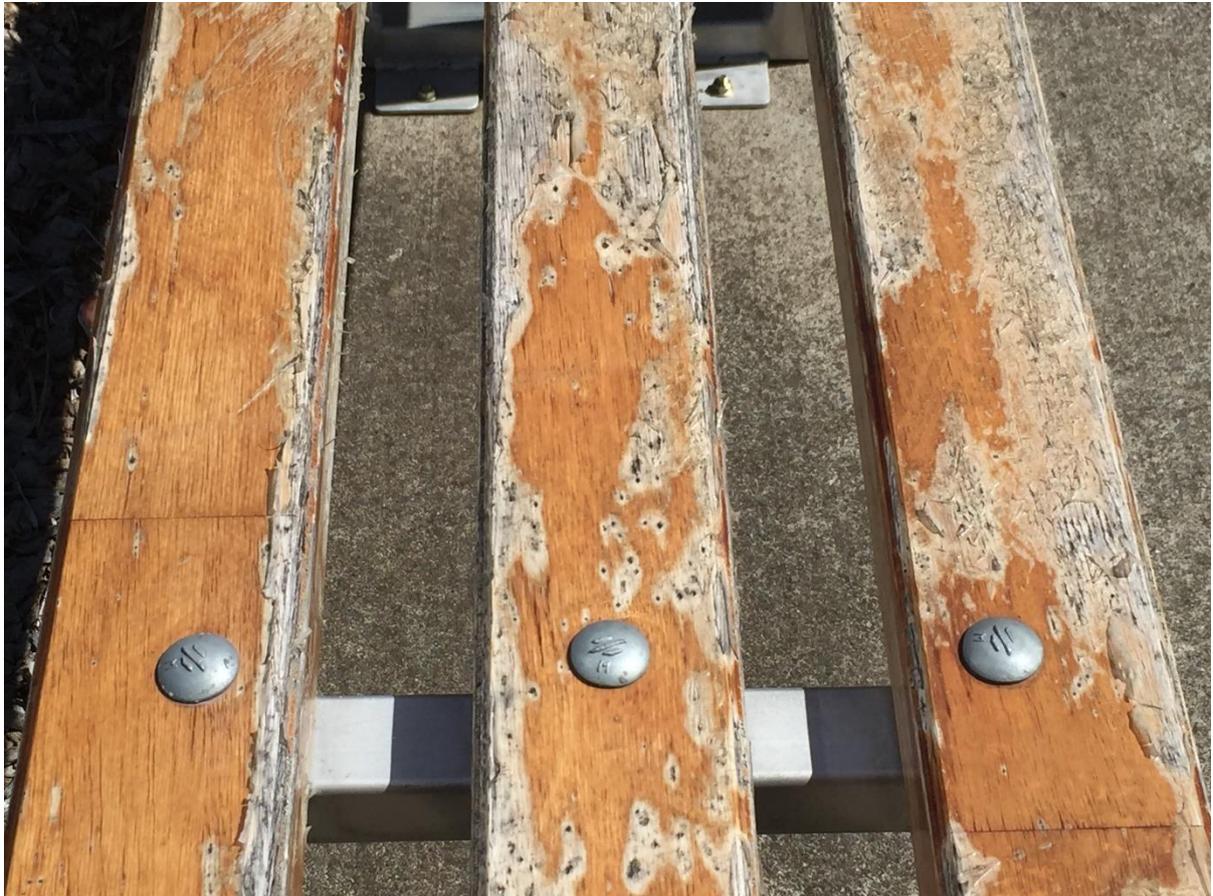
External Timber Furniture

In my new book, External Timber Furniture, I give a chapter each to timber finishes and maintenance. The above figure clearly demonstrates why this is needed. I am having copyright issues with some of the images and until that is resolved I cannot make it available. Can you help with images of :-
