# Ted's News

## August 2018

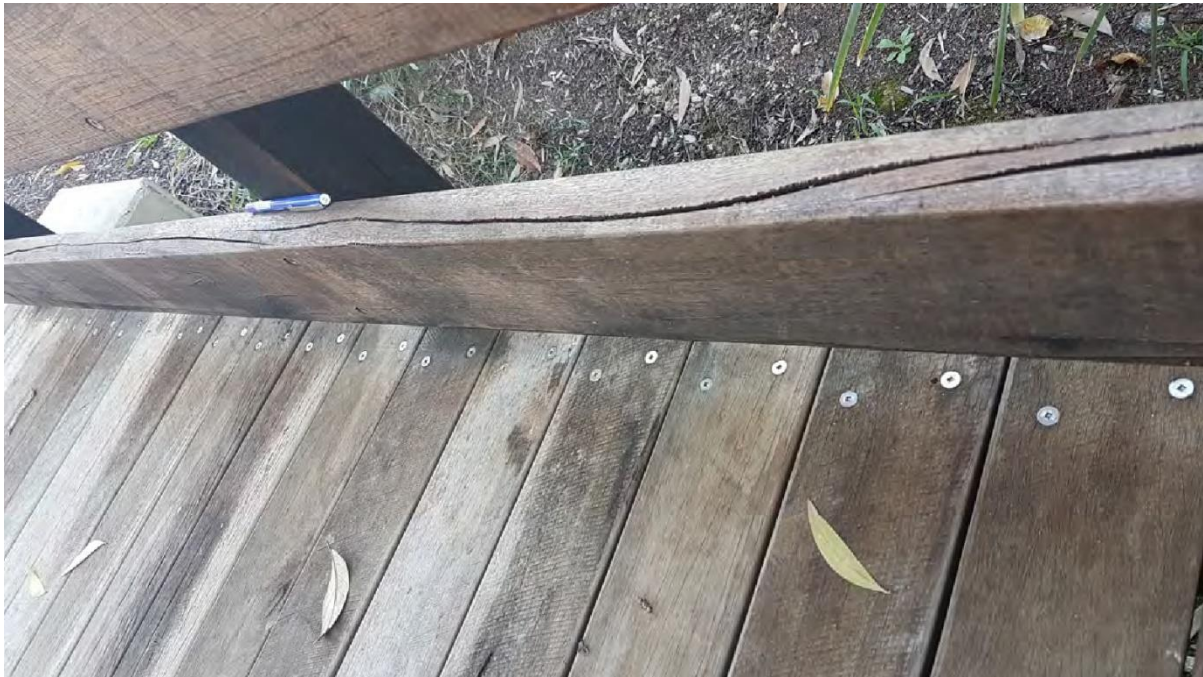
What you are looking at is a tight gum vein which is a vein with interconnecting tissue between both sides, as opposed to an open gum vein that does not have interconnecting tissue. It obviously hasn't held together when exposed to the weather as it probably would have done in a roof truss. This piece of timber met the grading requirements of F22 and also F17 appearance grade where tight gum vein is unlimited. Despite meeting one or two grades higher than most specify for handrail, timber like this should never be sent to site. This isn't because (at least in this case) it is unfit for purpose, rather instead you generally can't trust contractors to look at the timber, know what they are looking at, and place natural feature like this down or away from view. Thoughtful placement would have seen this piece perform as well as clear timber.

It is almost impossible to get designers to break the bad habit of specifying exposed timber by using general house framing grades and instead use grade descriptions that are appropriate for their intended use. When it comes to getting independent confirmation grading - forget it, until it goes wrong. In my book *Grading Hardwood* you will learn that there is no appropriate Australian Standard grade for timber handrail and it will guide you how to write an appropriate specification. Then get confirmation grading. The book can be [purchased as a PDF](#) from me or a [hardcopy from Amazon](#). As a light hearted warning about poor specifications, I prepared this presentation, [The Parable of the Specification some years ago](#).

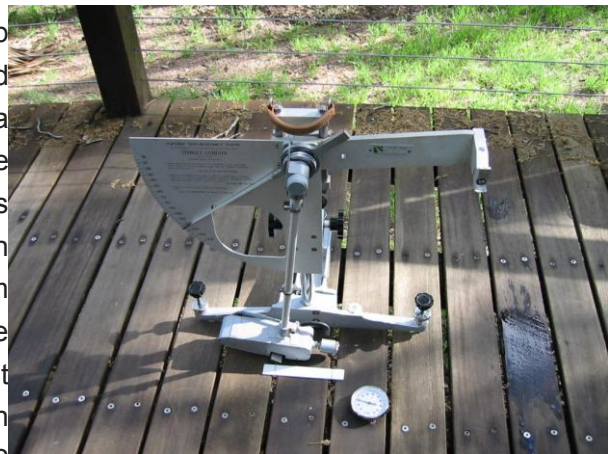
There is little information available on slip resistance of decking. Fortunately, Forests and Wood Products Australia are finalising a publication on the subject but at the moment the only information I have is testing that was undertaken for me by the University of Southern Queensland. The image to the left of a pendulum tester on sawn face decking was taken at the time. Pre-oiling with products such as Tanacoat exacerbates the issue but is less so with a rough sawn surface. My own testing resulted in R12 slip resistance with dry rough sawn Deckwood, lightly sanded and with a Tanacoat finish.

The issue is very complex and requires a PhD study to come up with a definitive answer. But my testing showed it was highly likely that someone would slip when dressed face decking is used. I have had years of experience of disappointed asset owners who have rung me after people had slipped. Sometimes they were facing legal action as a consequence. I know of at least one large deck where the asset owner had to roughen the surface after litigation.

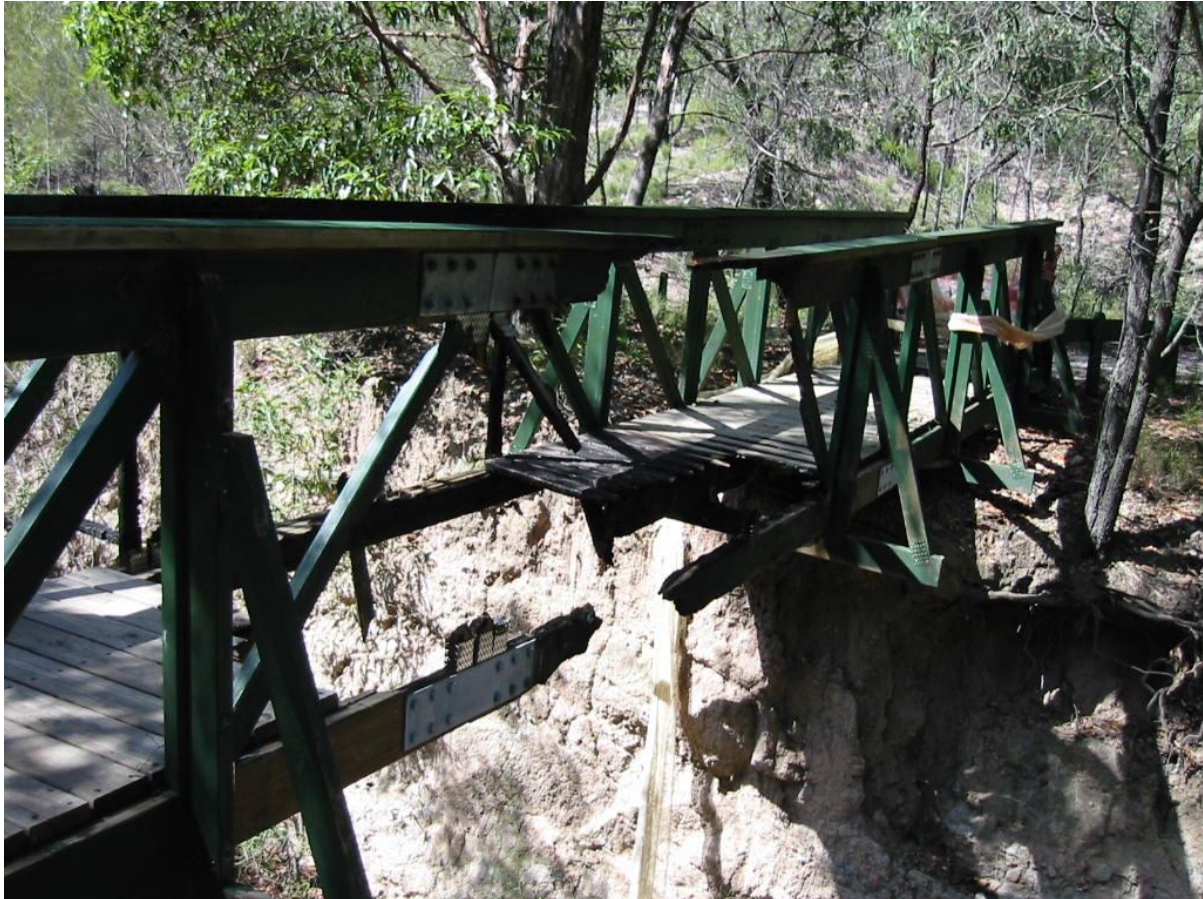
You really wouldn't want to be crossing this footbridge at night as you would be in for a rude shock. Even a novice at timber would have little trouble condemning this bridge. However, when it is less obvious, many really don't know what they are looking at, I am afraid to say. I can help with footbridge inspections. One recent customer said "I have several bridges that require repairs and by using your services I ensure the City is getting the best service, Again thank for your expertise." You too can tap into this expertise.

Incidentally, no surprises here, CCA treated pine (and hardwood with treated sapwood) continues to burn after the ignition source is removed due to afterglow caused by the arsenic in CCA. More on this in the [June newsletter](#) - scroll down to the section on posts.
