Ted's News

June 2021

[Tell me How to Detail it Correctly](#)

Lay Your Design Sins at the Foot of the Cross (Revisited)

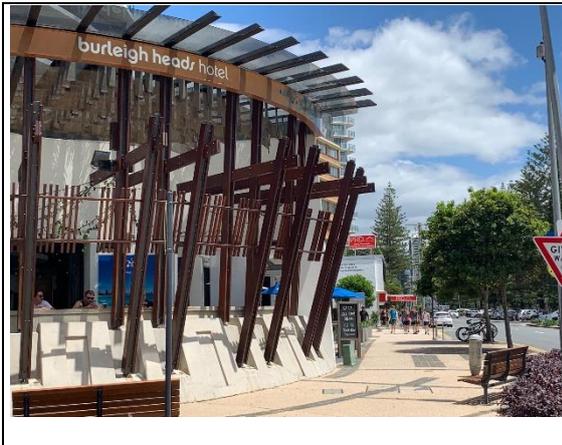
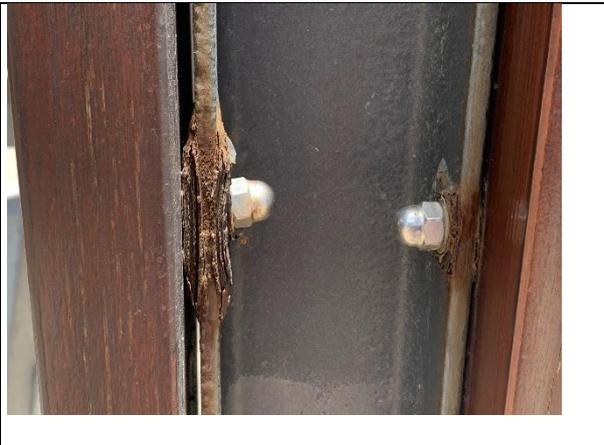
In April I asked my readers what was going on and how should this application be detailed at this site at the Gold Coast less than 200 metres from breaking ocean where painted steel is corroding badly around the stainless bolts. We are dealing with about as difficult an application as you can experience. Thank you to all who replied and I will summarise the opinions. Now I am assuming that the steel is galvanised and the paint was applied over it and possibly done on site. I may be doing everyone involved a grave disservice but it will suffice for the argument. Clearly we have galvanic action which is compounded by the salty air and spray and the galvanising may have exacerbated matters. The dissimilar metals are not insulated from each other so the steel column is sacrificing itself to protect the stainless steel fixing. Tightening the bolt could have damaged the paintwork and any insulation it provided as also could running a drill through a painted hole. (We always marked, removed, drilled then installed).

I will conclude with some words of wisdom from Paul Callum, Director, Structures at Bligh Tanner, "It can be difficult to catch all these situations e.g. gutters / downpipes etc. and are more prevalent in coastal as everyone is aware that stainless should be used where exposed but of course there are always these little spots that can catch you out."

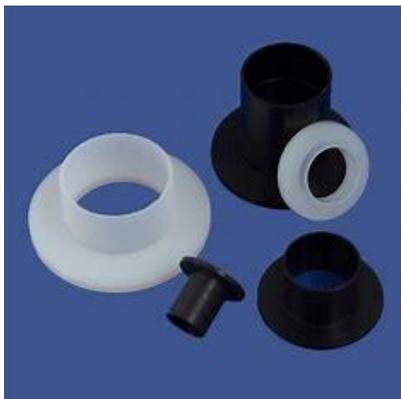
The bolt needs to be stainless as was used, so my suggestion for similar project would be to rely on a factory painted finish, not on galvanising. One such product would be [PPG's PSX700 with a zinc rich primer](#). (I used this product very successfully on [my truss bridges](#), ask Matt Hollywood of PPG for more info 0477 730 595) This would then be used in conjunction with a shouldered or "top hat" washer made from nylon for very positive insulation. I had no problem finding suppliers on the net and this image is from [Supreme Fasteners and Components](#).

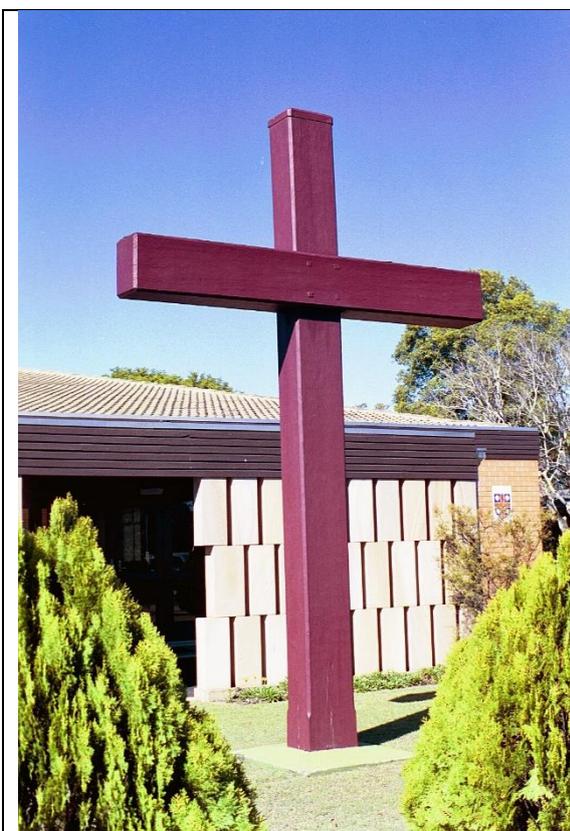
The Cross donated by our family in 1967 to St Albans Church, Gatton

Our family donated the cross at St. Albans Anglican Church in Gatton when the present building was constructed in 1967. It was made from 300x200 ironbark and set in concrete. which we all did back then. The Architect very wisely had a good slope on the concrete directing moisture away from the base. But eventually time took its course and decay set in - read about it here [May 2018 newsletter](#) Subsequent probing and drilling at ground line showed the timber to be very soft. Wisely the cross was removed with a view to reinstating in a metal base. The above image on the right shows how, just 100 mm above the groundline, the timber is sound and would have no trouble being in position for 100 years. So, half glass full says 50 years' service is great, half empty says it could have gone 100 years. There is a good discussion on how to engage with the ground in my guide [Timber in Playgrounds](#) and is covered in my CPD course, *Timber Joints*. But now, I give more emphasis on not installing in the ground for something that is critical, and especially if it is free standing.

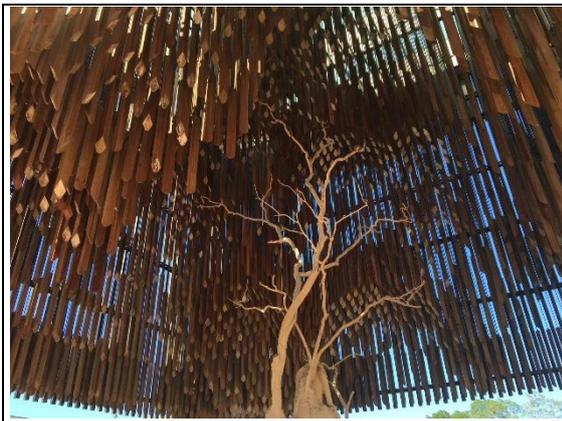
Tree of Knowledge - Barcaldine

There is a very remarkable timber structure in Barcaldine commemorating the "Tree of Knowledge" where it is said the Australian Labour Party had its roots. There are over 1000 pieces of 125x125 hardwood hanging from the top. [You can read about it in my guide, Architectural Timber Battens](#). If one fell, it doesn't bear thinking about. One day someone found a nut and washer on the concrete. The memorial was closed down and for three days a friend examined every piece only to come to the conclusion that the village idiot (or an equally stupid tourist) had thrown them on the ground for some fun. Now that timber roller coaster at SeaWorld on the gold coast has quite a few nuts, many times what was used at Barcaldine. What would you do if you found one or two on the ground? What a job trying to find which bolt it came from or was it only just a disgruntled employee knowing how to inflict maximum pain for minimum effort.

If you ever designing or building a large timber structure, it is worth considering how do you keep one jump ahead of the idiots. In a case like this I would be ensuring that there was some way of clearly identifying the nut used during construction from one purchased at the local bolt and nut store. (And of course, they may have done this.) It could save a lot of grief.
