# Ted's News

## December 2017

### [Another Deck Collapse](#) [How to Confirm the Correct Treatment Has Been Achieved](#) [The Importance of Grading Timber](#) [Lessons From a 30 Year Old Mangrove Boardwalk](#)

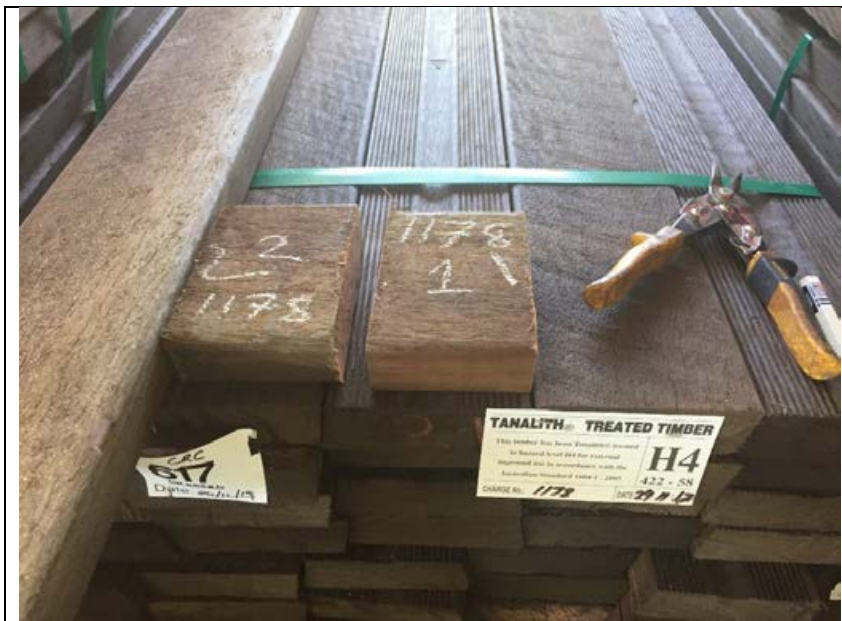
The A and B sample identified with the charge number.

The samples shown above that were taken in Cairns, along with others from the four charges involved., have been dispatched and logged into IVS's portal. The portal provides:

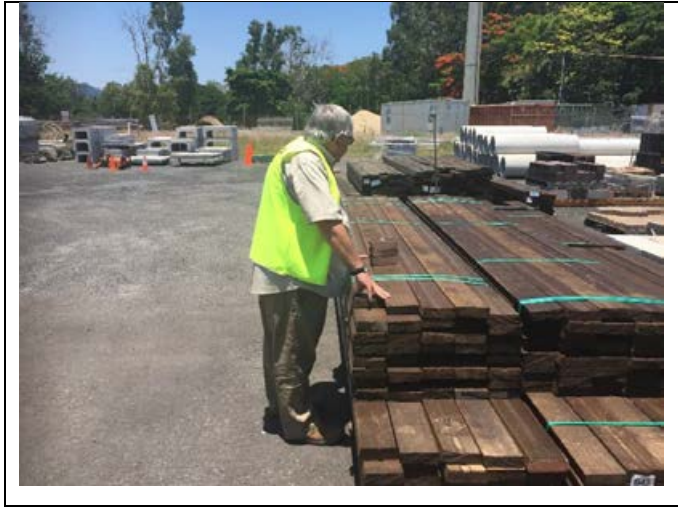
I am here pictured in Cairns inspecting timber produced to the [Deckwood](#) specification. I was impressed with the level of conformance. The mill did say that they had exceptional logs but at the end of the day it is about culling out non-conforming material at the mill before the timber is delivered. The last batch I graded to the same specification had a 50% non-conformance including untreated lyctus susceptible sapwood!

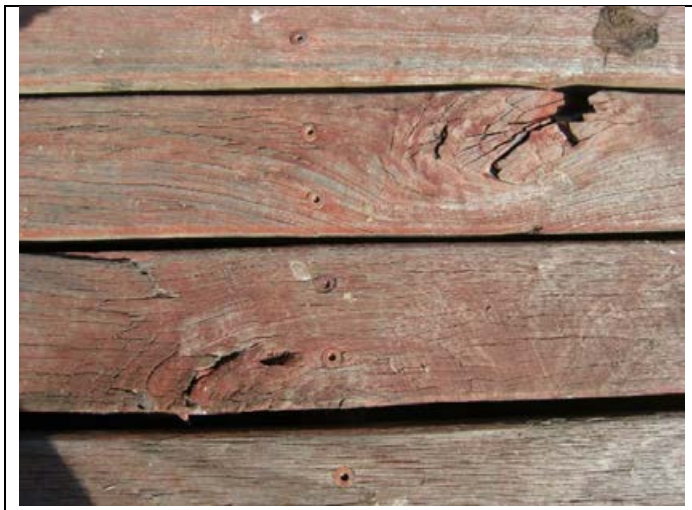
Consider this decking which overall had about a 75% non-conformance. The mill didn't give a hoot (I could have used a much stronger word), The builder didn't give that much stronger word, and the certifier had absolutely no idea what he/she was looking at. There is no point putting effort into design if you allow this! Responsible suppliers deserve and need your protection and if you don't, what will you have

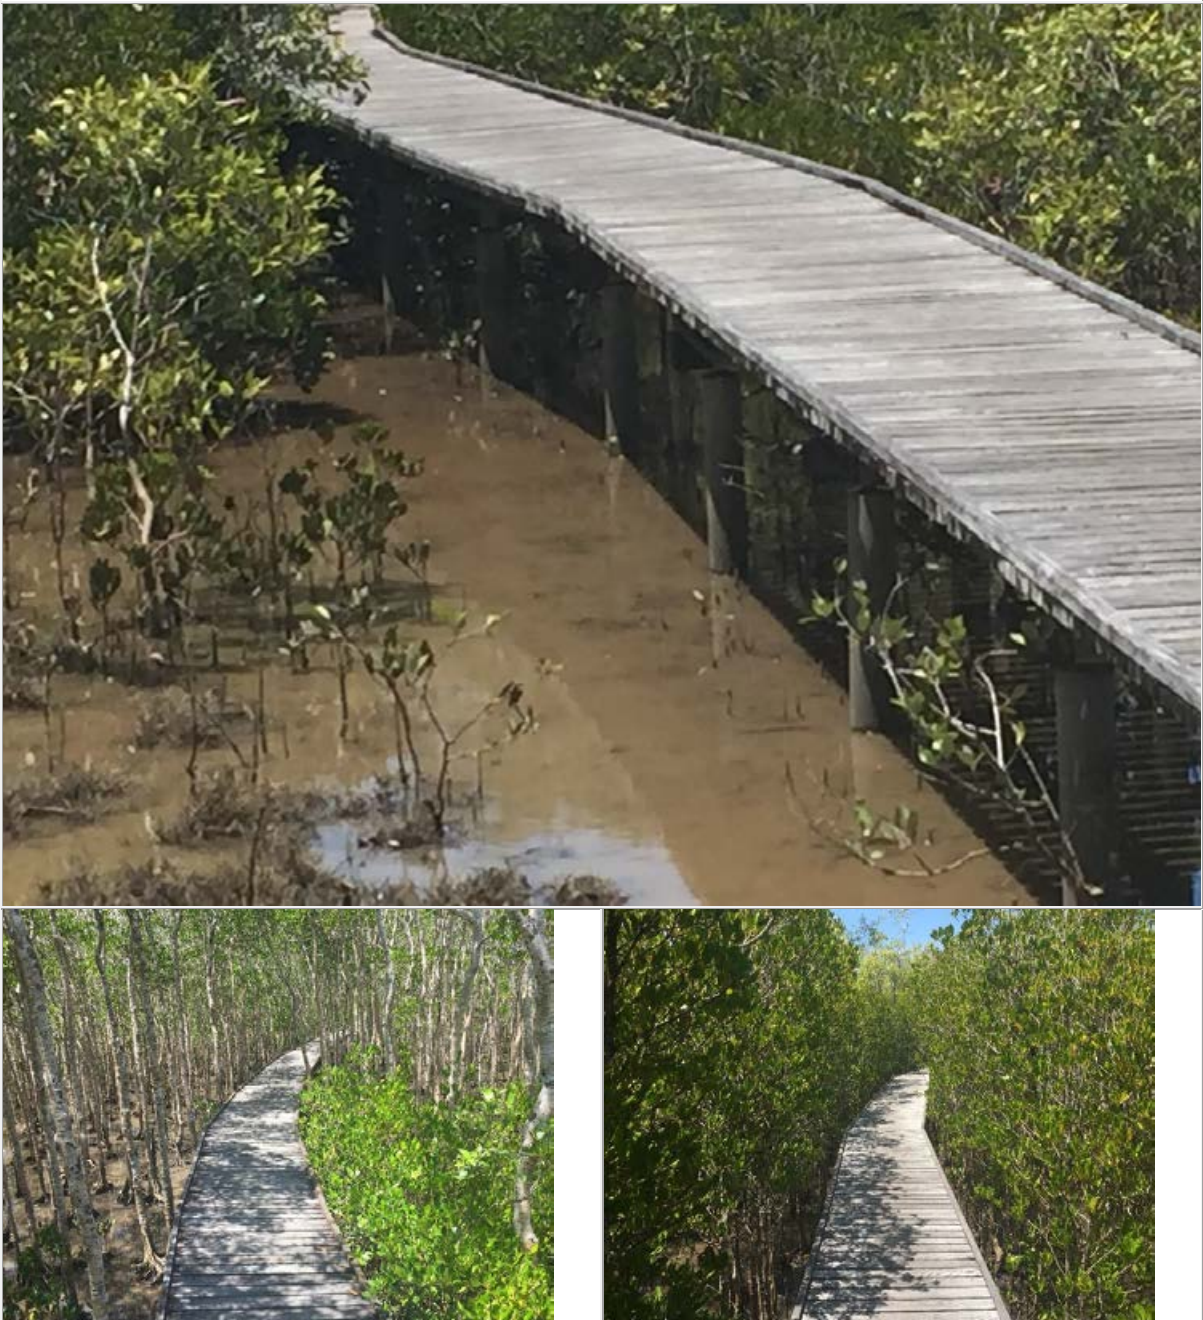
The [Jack Barnes Bi-centennial Mangrove Boardwalk](#) is situated adjacent to the Cairns Airport and was constructed 30 years ago as a work for the dole project. It is still in service and, having walked it, I believe there are lessons to be learnt from it.

The piles are bamboo about 6m long which were cut off about a half a metre below the surface and a length of sewer pipe was spliced in and filled with concrete. In places they have sunk but, overall, it is functioning as at most it only has to support a handful of people. As far as supporting the normal design load of 5 kPA, 4.5 kN it would fail. The local footy club is no longer allowed to run on it as the boardwalk developed a "bow wave" action. Compare the piles to those at the Nudgee Beach

The timber is in remarkably good condition and has many years service left despite already being 30 years old. This is largely because the top surface of most boards are clear of defect. Those with defect have degraded but they are a very small minority. You cannot get this grade of timber now if you ask for F14 or F17 and that is why [Deckwood](#) was developed. You need to purchase my book on [Grading Hardwood](#) to understand why a very tight specification is required for decking.

The fasteners and the brackets are all galvanised and this deck is fastened with galvanised flat head nails. The areas closest to the creek have experienced the most corrosion but, being 30 years old these would have been Australia made bolts which perform much better than the low cost imported bolts. See [June 16 newsletter - Galvanised bolts more variable than timber](#). I recommend stainless steel. A detailed argument for this is given in my book [Timber Joints](#).

The foundations that are sinking in places do need some attention, probably more for aesthetics than safety but, once attended to, provided the traffic remains light the superstructure will give many years of satisfactory service.
